Playing the Long Game

Warren Chung, Solex Thermal Science, Canada, discusses maximising the longevity of fertilizer processing technologies through preventative maintenance.

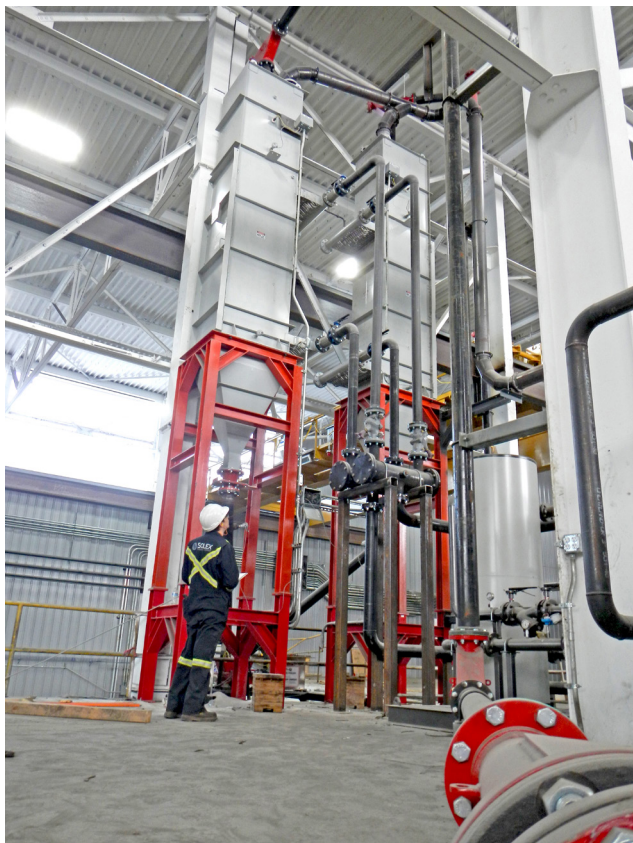
Figure 1. Moving bed heat exchangers (MBHEs) combine the thermal efficiency of plate heat exchange design with the science of uniform mass flow to cool a full range of urea, nitrate- and phosphate-based products.

MBHEs combine the thermal efficiency of plate heat exchange design with the science of uniform mass flow to cool a full range of urea, nitrate- and phosphate-based products. The compact tower-like design – which often has a physical footprint of approximately 2 m x 2 m – cools the fertilizer product by conduction instead of convection (e.g., air cooling).

Free-flowing material is top-fed to the exchanger and slowly passes through a vertical series of heat exchange plates by gravity. Each heat exchange plate contains a circulating heat transfer fluid. The plate spacing, plate sizing and number of plates are determined by the particle size and thermal loading requirements. The flow of solids is controlled by a discharge control device that is integral to the MBHE's performance.

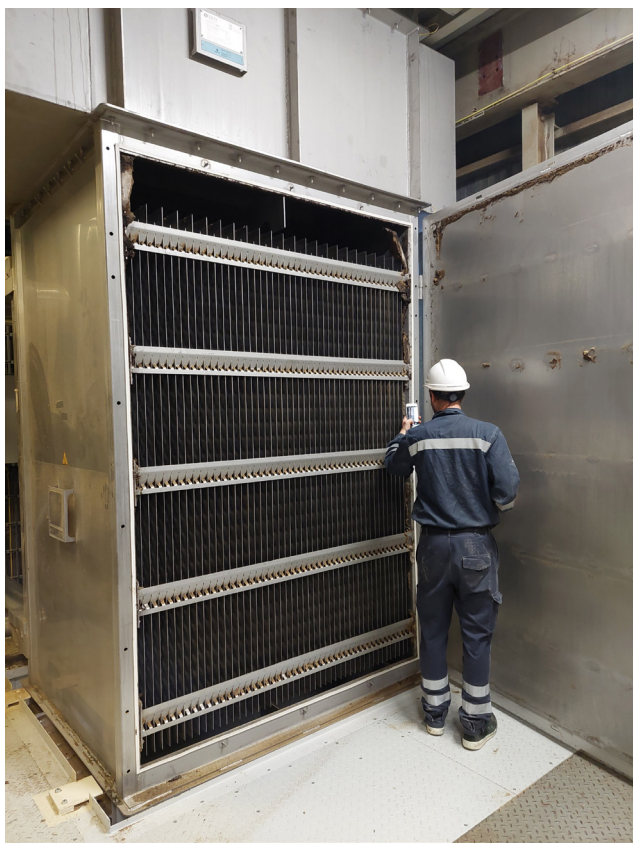
Figure 2. MBHEs and common trouble areas such as the heat exchange plates should be regularly cleaned and inspected.

As it relates to preventative maintenance, MBHEs should be regularly cleaned and common trouble areas inspected – notably the heat exchanger plates. These components are in constant contact with the product as it flows between channels and could wear over time. This is particularly applicable in environments where the quality of the heat transfer fluid is compromised and/or other process conditions change.

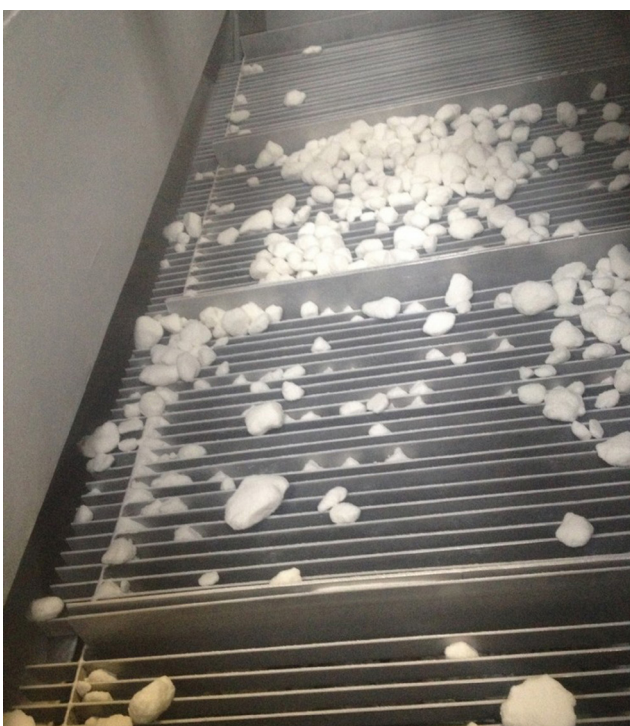
Figure 4. Obstructions at the top and/or within heat exchange plate banks can occur when off-spec particle size materials are introduced.

Take product blockages for example. An MBHE operates most effectively when uniformly sized product moves predictably through the heat exchanger. Yet, obstructions within heat exchange plate banks can occur when off-spec materials are introduced.

- Divert product away from plates, lowering the effective heat transfer surface area within an MBHE.
- Create preferential flow scenarios that lead to increased flow velocities elsewhere. This can lead to outlet temperature inconsistencies, resulting in a product that does not meet process requirements due to insufficient residence time in the heat exchanger.

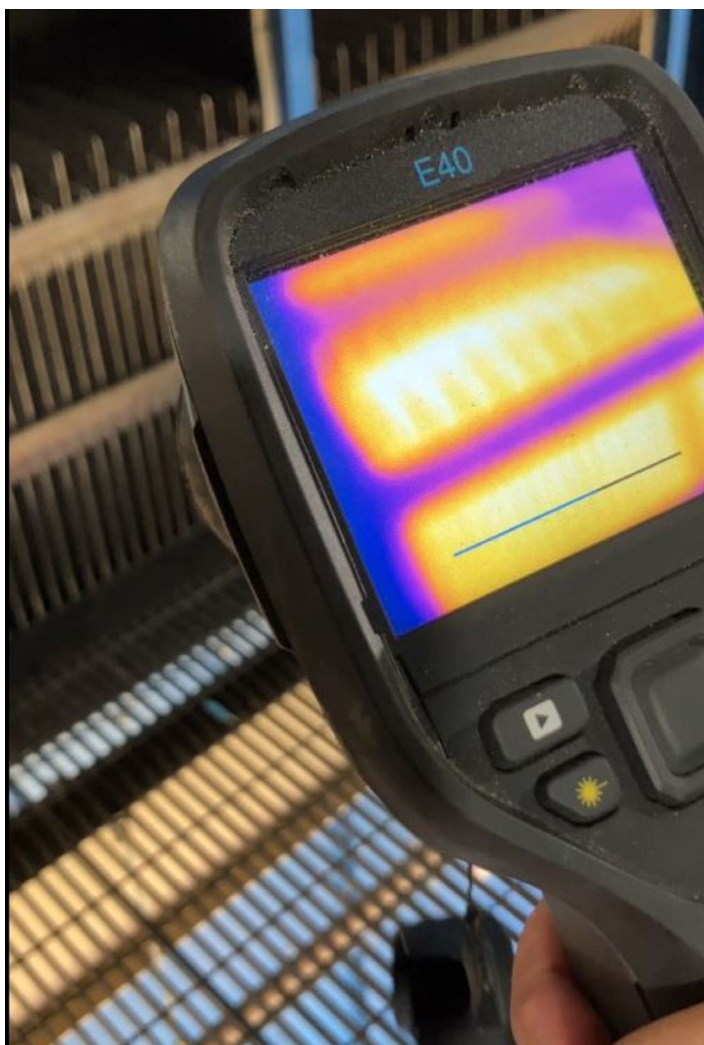
Figure 6. A heat camera can be used to diagnose whether specific spots of the heat exchanger plates are heating up more than others, or indicate if there is poor flow of the heat transfer fluid within the plates.
